SUBJECT: LA-6 Model

DATE: March 1 , 1934

This Bulletin supplies detailed supplementary information to that issued in Machine Service Bulletins No. 161, Supplements A, B, C and D, and 165, 167 and 177.

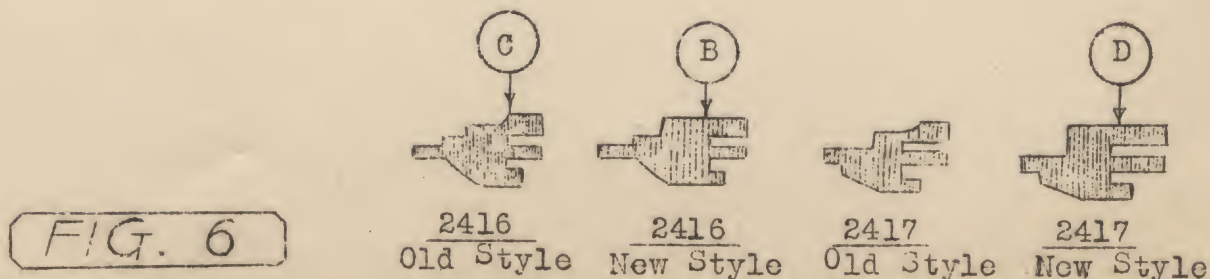
An improvement has been made in the carrying dogs by adding a small amount of stock on the top of the dogs at the points where they contact the feet of the wedges. See (B) and (D), Figure 6. In LA-6 models, due to the use of round tooth gears in the extra carry unit, it is necessary to set a slightly higher mesh between the dial gears and intermediate gears than in other L models. This higher mesh causes the wedges (A) to be depressed slightly later by the carrying pins than with the deep mesh, and we have found that this delay, even though it is slight, causes the wedges, when they are depressed, to strike the top of the dogs rather than to drop in front of them. In order to overcome this condition, we have added a small amount of metal to the top of the dogs so that the delay in depressing the wedge is compensated.

Figure 3 illustrates the correct engagement of wedges (A) with the new style 2416 dogs (B).

Figure 4 shows the incorrect condition caused by the wedges (A) dropping late and riding on top of the 2416 old style dogs (C).

Figure 5 illustrates the correct engagement of the wedges (A) with the new style 2417 dogs (D).

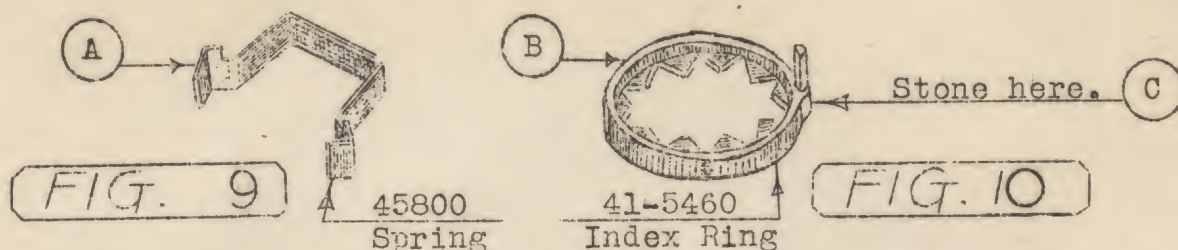
If a wrong number registers after a clearing operation, or if numbers register when clearing and no constant is set in, it is caused either by springs (A) being broken or too weak. If the index rings (B) are made of steel they should be replaced by the newer brass rings. If spring (A) is made of steel it should be replaced by the new beryllium bronze spring. When the inside of the dial shows that the index ring (B) has been rubbing against it, the ring should be stoned at (C).

It is important that the bottom of the index ring (B) be free from burrs, both where the pin is riveted and around the edges of the teeth. When the spring is assembled to the dial, the ends should be bent correctly and the ring should be carefully assembled, as shown in Bulletin No. 161-D, Plate 50. When the dial is assembled to the collar, if care is not used, the ends of the spring, which should act on the teeth of the ring, may slip out and get between the ring and the inside of the dial. This is especially likely to occur with the eleventh dial.

If wrong figures are registered when the constant is being set into the carriage, it may be due to springs (A) being too weak, strong or broken. Faulty dial plunger action will also cause this trouble.

The left hand ends of the dial collars (D) have been reduced slightly in diameter so that they may be assembled more easily. If collars (D) have a flat on the flange which form a bearing for the index ring (B) the corners (E) on the left side should be broken with a stone.

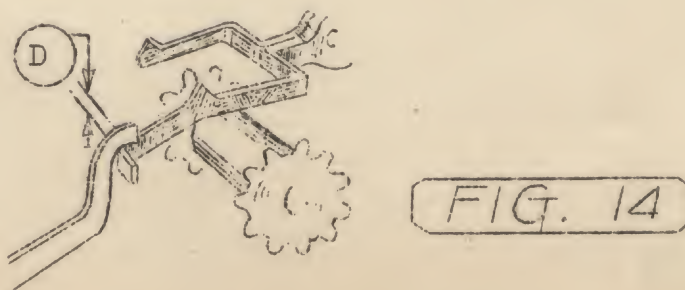
If, after the multiplication counting dial has been returned to zero the machine continues to run in the forward direction, or if the machine continues to run in a forward direction when the carriage shifts to either of the first two column, (D), Plate 8, is not adjusted close enough to the carry pin. NOTE: Whenever changing this adjustment, it is necessary to change the adjustment of (H) by bending (G). See Plate 8.

Excess clearance at (D) may also cause this trouble. See Figure 14.

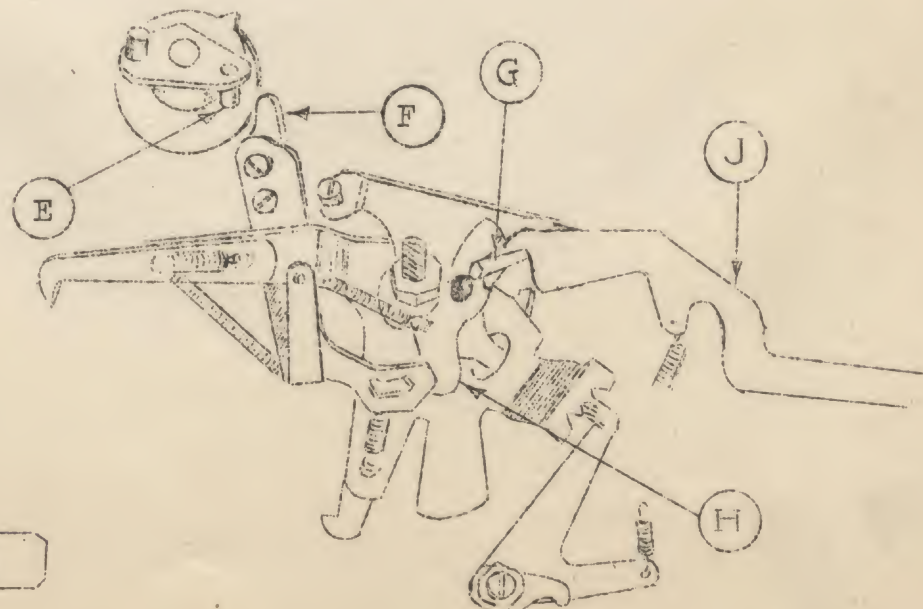
If a machine makes one or more reverse cycles after shifting in multiplication, latch (D) is adjusted too far from pin (C), or there is too much clearance at (J), Plate 8.

If the machine continues to run forward after the carriage has shifted to the first column in multiplication, pin (G) on end of the division lever is not properly adjusted by the division lever click (J) in relation to latch (H), to reset the clutch yoke trip arm to neutral.

If the machine should shift and stop in either multiplication or division, (F) is not properly adjusted to (E).

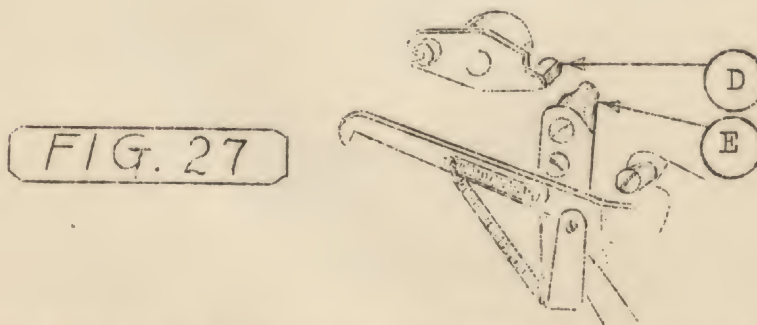
A good adjustment of the clutch yoke trip arm (E) with stud (D) is important.

Ascertain that the right hand ends of hub (F) and shaft (G) do not interfere with the cover case, 41-660. To remedy this condition grind the face of hub (F) and shaft (G).
